Comments on Recent Observations of Faintly Luminous Formations (FLF) Captured Using Phantom High-Speed Cameras

Jonathan D. Hill and Carlos T. Mata
Scientific Lightning Solutions
Titusville, FL, USA
d.hill@sls-us.com

Abstract— During 2015, the high-speed camera network at Kennedy Space Center/Cape Canaveral Air Force Station was used to study a newly-reported optical phenomenon associated with the attachment process of lightning leaders to ground. This phenomena, termed the “Faintly Luminous Formation (FLF)” by researchers in the United States has significant implications on the definition of when and where the attachment process actually begins, important parameters that impact the design of successful lightning protection systems for assets and infrastructure. Five close (<1.5 km) lightning leader/return stroke sequences were simultaneously imaged by Phantom M310/V711 and V1610 high-speed cameras. In all cases, the M310/V711 cameras recorded FLF in a single pre-return stroke frame while the V1610 cameras recorded no evidence of FLF. The data provided in this paper indicates that FLF observations shown here and in recent studies in the United States and China may be digital camer

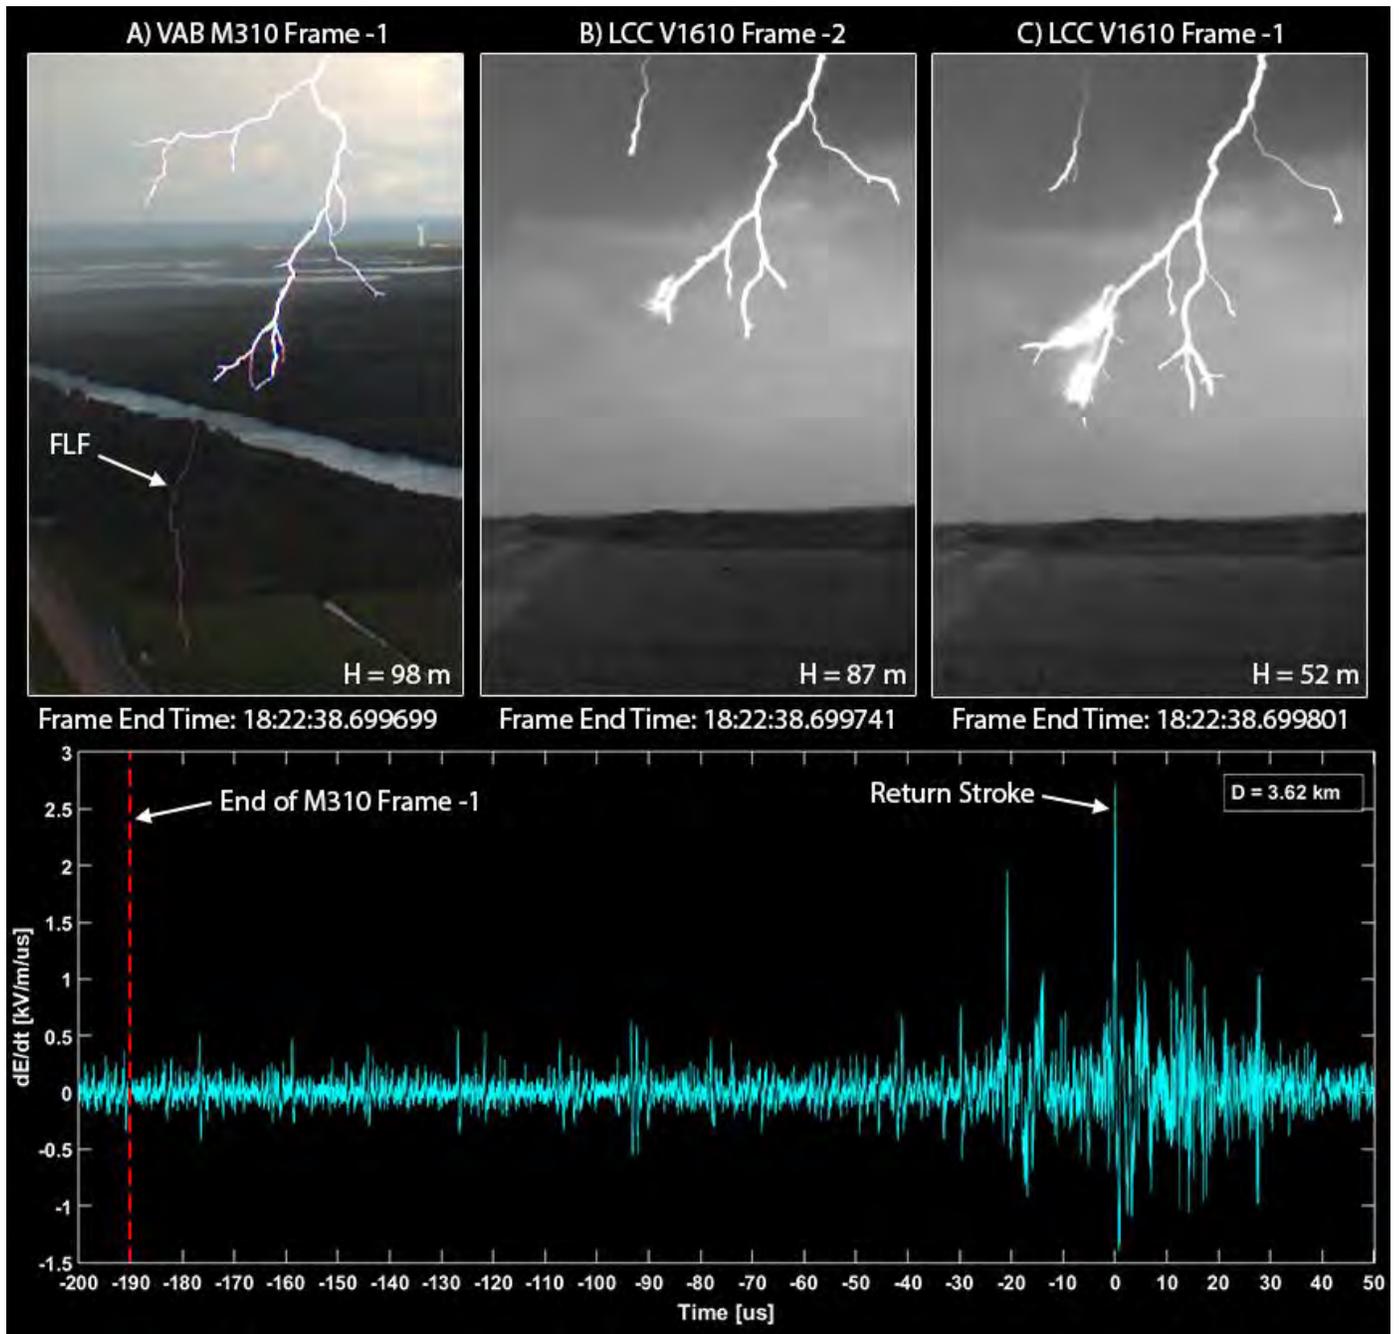
Fig. 1. Event 1 high-speed video images and dE/dt waveforms recorded on August 20, 2015 at 18:22:38.699 (UT), A) VAB M310 pre-return stroke frame showing FLF, B-C) consecutive LCC V1610 pre-return stroke frames not showing FLF.

The first event studied occurred at 18:22:38.699 (UT) on August 20, 2015. The flash had two ground termination points, with the second ground termination point occurring within the field of view of both the M310 located on the VAB roof and the V1610 located in the LCC. The flash struck ground about 590 m east of the VAB camera. The pre-return stroke frame captured by the M310 is shown in Fig. 1A, while the two pre-return stroke frames captured by the V1610 are shown in Fig. 1B and Fig. 1C, respectively. The IRIG-B times corresponding to the end of each frame exposure are provided beneath each

image. These times are expected to be accurate to within a few microseconds. Fig. 1A shows a continuous FLF channel (group A event from *Tran et al.* [2015a]) between the tip of the downward leader and ground. The FLF channel has lower bound length of 98 m with the M310 frame ending 189 μ s prior to the dE/dt return stroke peak. The corresponding dE/dt waveform measured 3.62 km southeast of the strike location is also shown in Fig. 1. The V1610 image shown in Fig. 1B recorded two frames prior to the frame containing the return stroke and with higher sensitivity than the M310 image shown in Fig. 1A shows no evidence of FLF between the tip of the downward leader, located at an altitude of 87 m, and the ground. Note the V1610 frame exposure ended 42 μ s after the M310 exposure shown in Fig. 1A. The downward leader propagated to an altitude of 52 m in Fig. 1C, again with no FLF channel visible. The V1610 image shown in Fig. 1C ended 102 μ s following the M310 frame containing the FLF. The V1610 image in Fig. 1C also shows a short luminous channel segment separated from the downward leader tip, likely a space stem/leader associated with the negative leader step formation process (e.g., *Biagi et al.*, 2009, 2010; *Hill et al.*, 2011). The corresponding dE/dt waveform also clearly shows impulsive leader stepping activity between the end of the M310 frame and the return stroke peak, similar to the characteristics reported by *Tran et al.* [2014, 2015a, 2015b]. In this case, there was no UCL imaged by either the M310 or the V1610, likely indicative that the UCL occurred during the return stroke frame and was therefore masked by the return stroke luminosity.

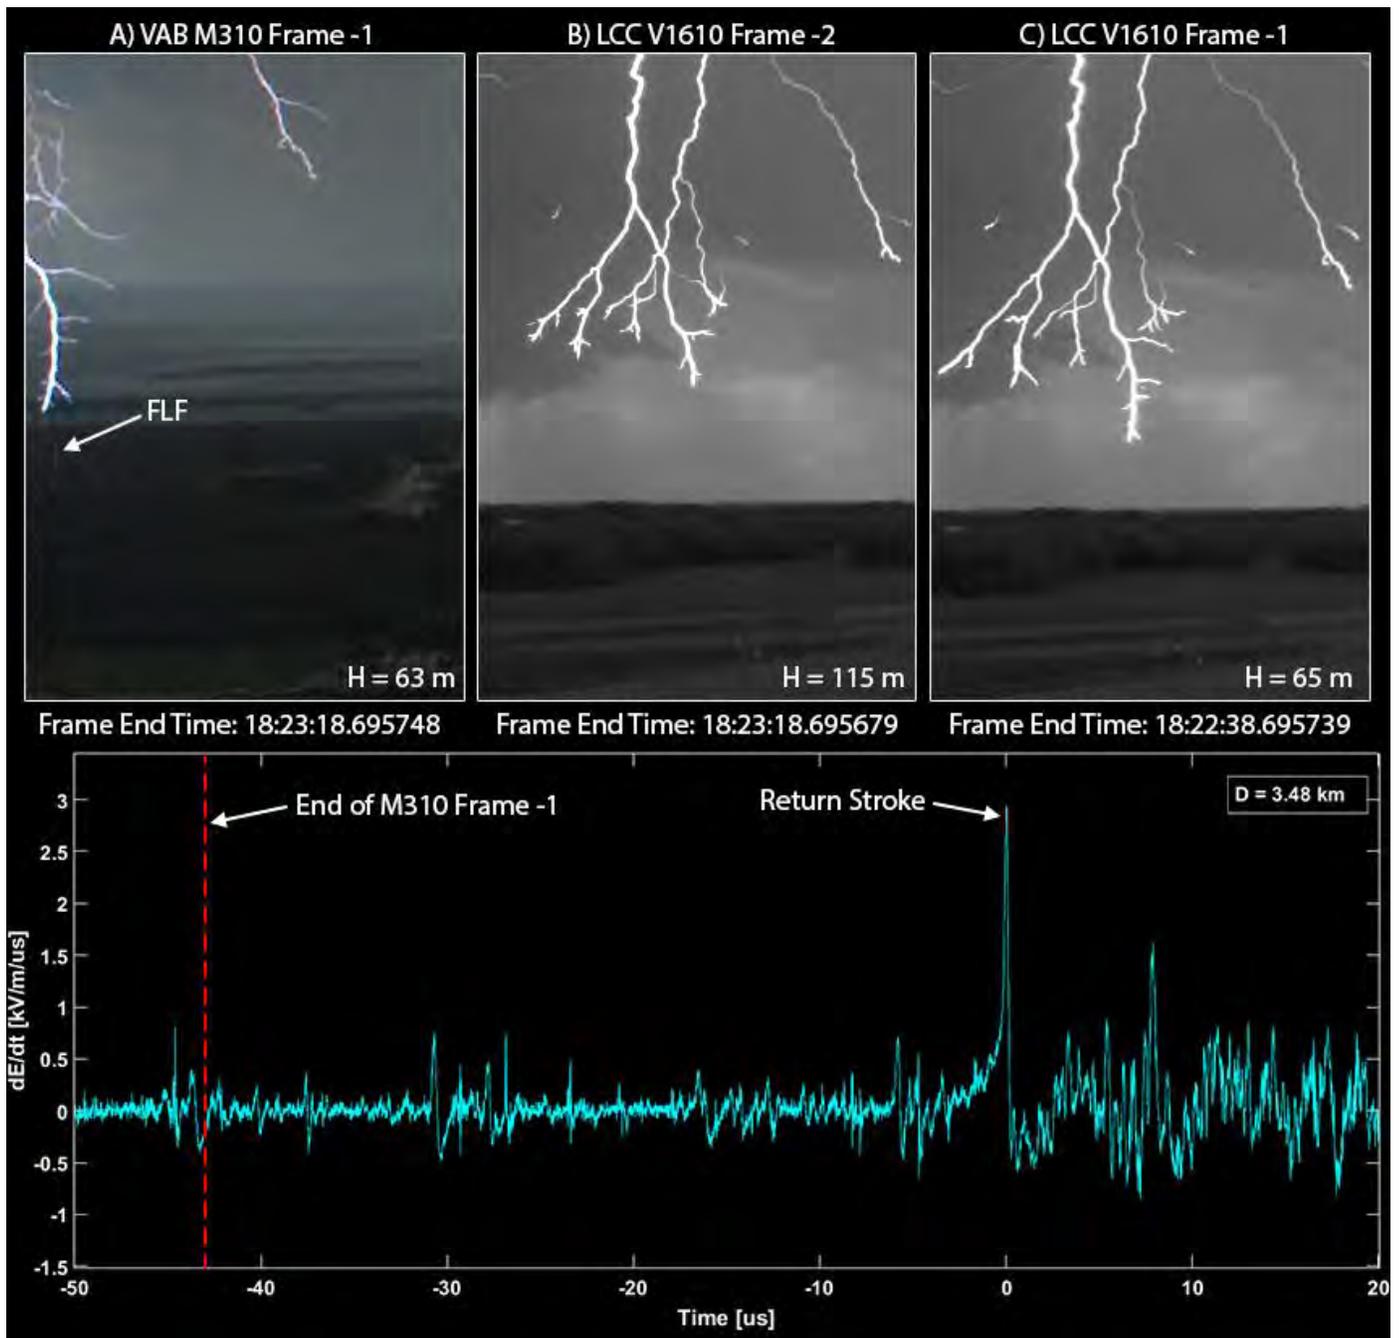
Fig. 2. Event 1 high-speed video images and dE/dt waveforms recorded on August 20, 2015 at 18:22:38.699 (UT), A) VAB M310 pre-return stroke frame showing FLF, B-C) consecutive LCC V1610 pre-return stroke frames not showing FLF.

Event 2 was recorded 40 seconds after Event 1, at 18:23:18.695 (UT) on August 20, 2015. The first stroke terminated on ground 1,361 m to the NE of VAB camera. Fig. 2A shows a continuous FLF channel between the tip of the downward leader and the strike point with length of about 63 m. The second frame prior to the return stroke (Fig. 2B) recorded by the V1610 in the LCC ended with the downward leader at an altitude of about 115 m, while the pre-return stroke frame (Fig. 2C) ended with the downward leader at about 65 m altitude, just above the ending location in space of the downward leader captured by the M310 in Fig. 2A. There is no evidence of any FLF channel in either of the pre-return stroke frames captured by the V1610. The V1610 pre-return stroke frame in Fig. 2C ended 9 μ s prior to the end of the M310 pre-return stroke frame in Fig. 2A, so it is possible (yet unlikely)

that the FLF developed completely in this $9 \mu\text{s}$ time window, and was thus undetected by the V1610. Like Event 1, the dE/dt record measured 3.48 km to the southeast of the strike location shows clear evidence of leader stepping between the end of the pre-return stroke frame captured by the M310 and the dE/dt return stroke peak. No UCL was imaged in this case by either the M310 or V1610.

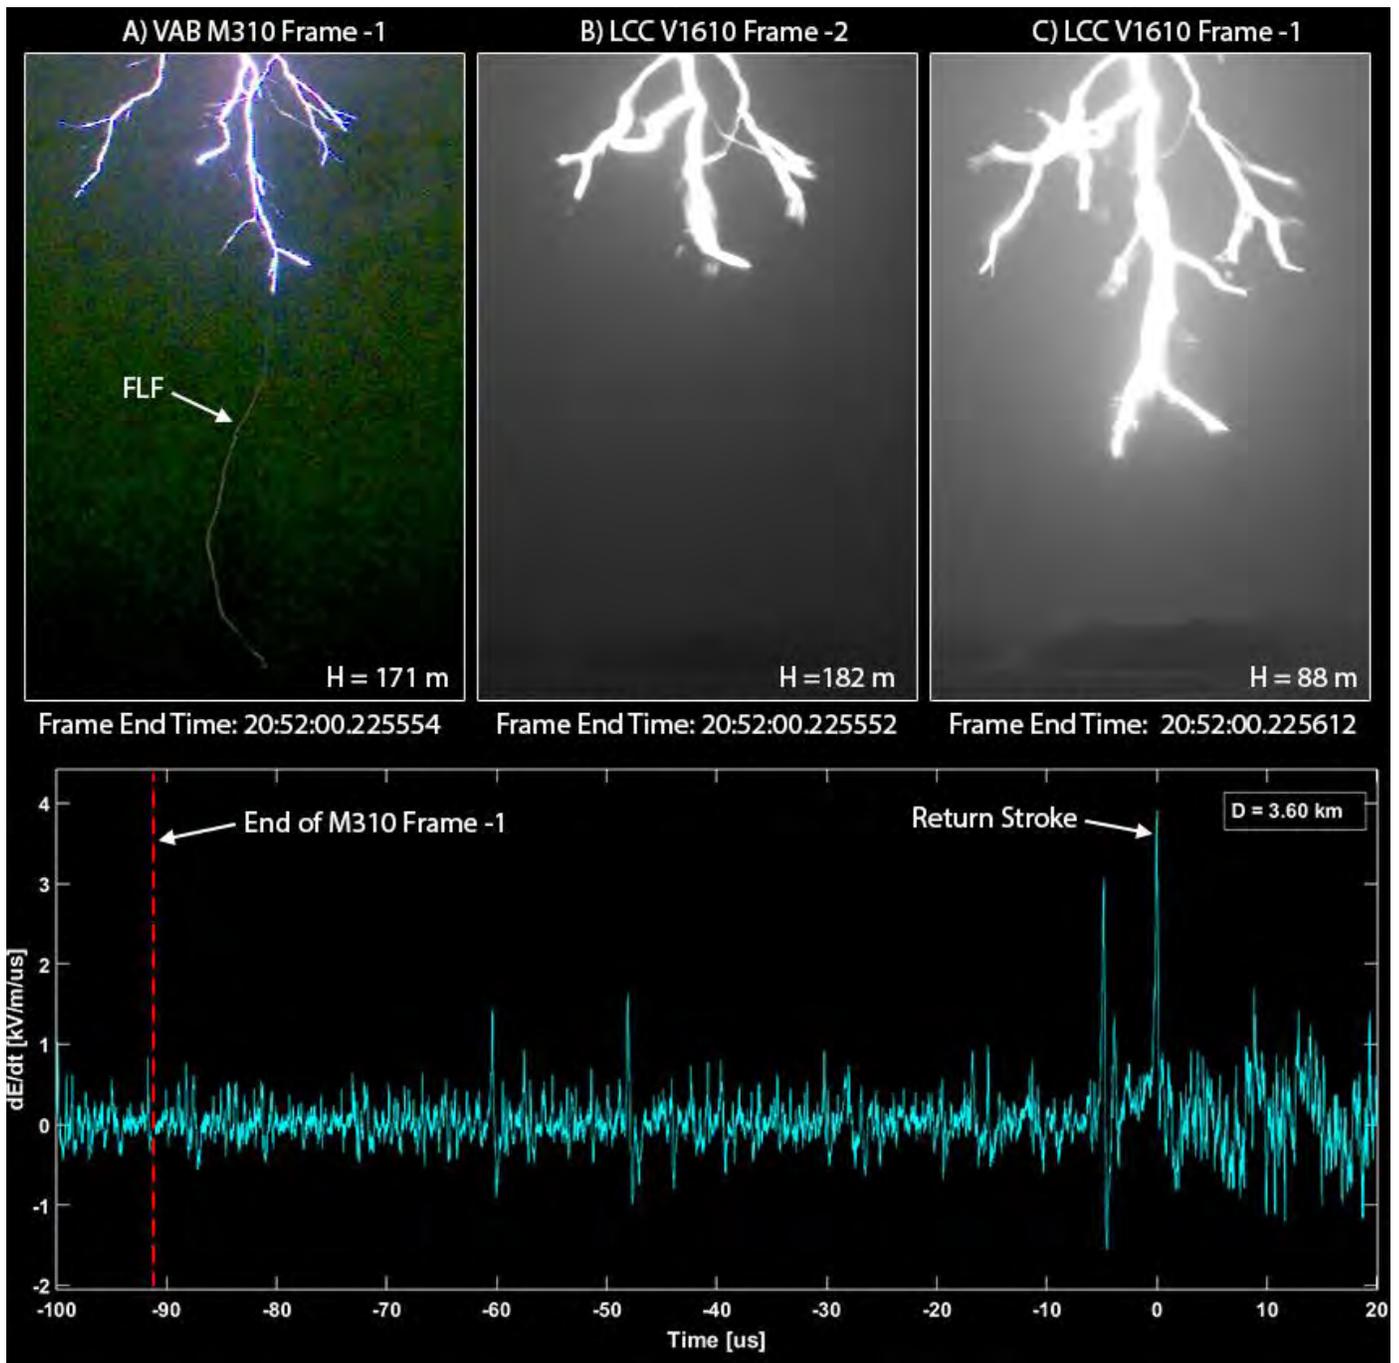
Fig. 3. Event 3 high-speed video images and dE/dt waveforms recorded on August 26, 2015 at 20:52:00.225, A) VAB M310 pre-return stroke frame showing FLF, B-C) consecutive LCC V1610 pre-return stroke frames not showing FLF.

The third FLF event was recorded on August 26, 2015 at 20:52:00.225 (UT) by the M310 on the VAB roof. The strike terminated on ground about 741 m east of the VAB. In Fig. 3A, the continuous FLF channel appears to extend 171 m between the tip of the downward leader and ground. The M310 exposure ended about $91 \mu\text{s}$ prior to the return stroke dE/dt peak shown in Fig. 3. The two frames prior to the return stroke recorded by the V1610 in the LCC are shown in Fig. 3B and Fig. 3C,

respectively. The V1610 frame shown in Fig. 3B ended only 2 μ s prior to the M310 pre-return stroke frame shown in Fig. 3A, yet no evidence of FLF is visible in the V1610 exposure. The leader propagated downward to an altitude of about 88 m at the end of the V1610 exposure shown in Fig. 3C, again with no FLF present between the leader tip and ground. The exposure shown in Fig. 3C ended 58 μ s following the end of the M310 pre-return stroke frame. Based on the dE/dt leader steps waveforms shown in Fig. 3, the stepped leader clearly continued to propagate downward through the spatial region

shown to be occupied by the FLF channel in Fig. 3A without being affected.

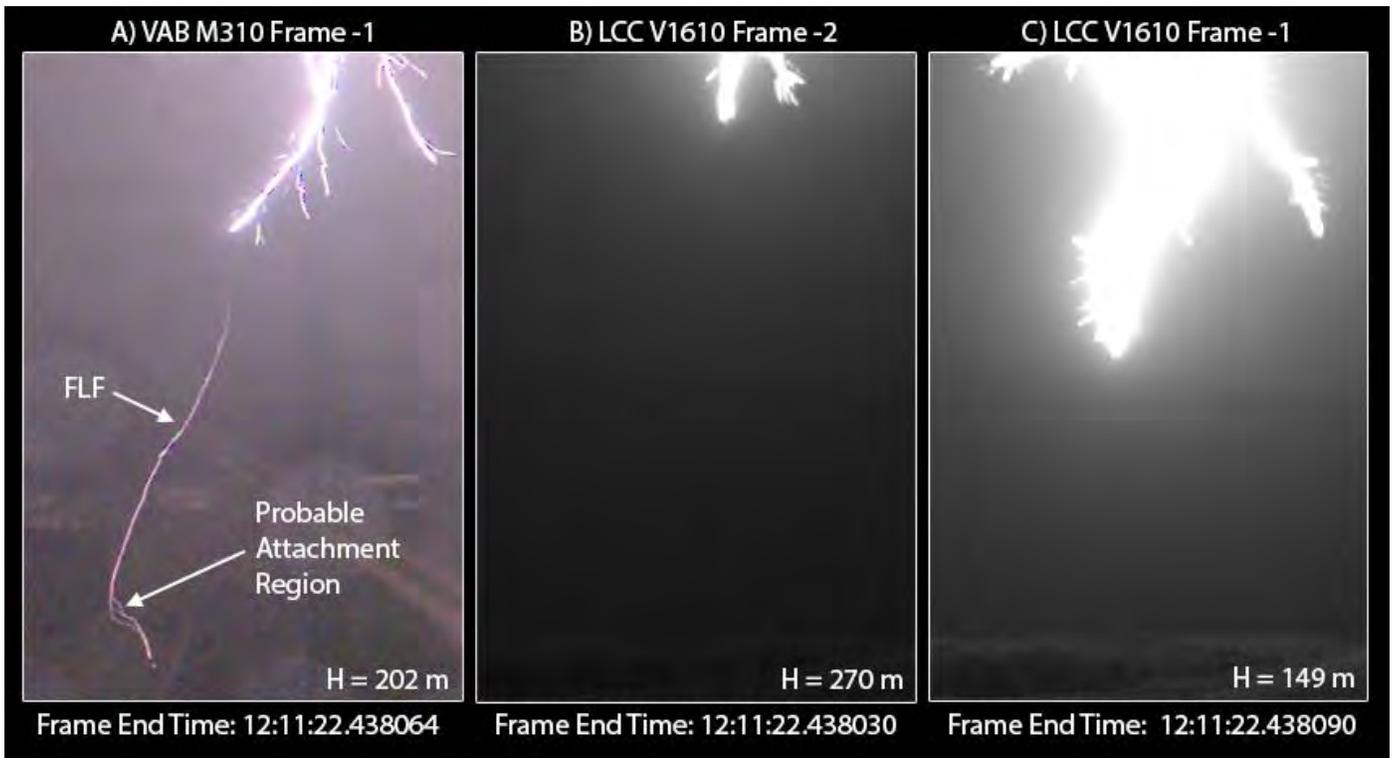
Fig. 4. Event 4 high-speed video images recorded on August 30, 2015 at 12:11:22.438, A) VAB M310 pre-return stroke frame showing FLF, B-C) consecutive LCC V1610 pre-return stroke frames not showing FLF.

Event 4 occurred on August 30, 2015 at 12:11:22.438 (UT). The discharge struck ground 756 m east of the VAB and was imaged by both the M310 on the VAB roof and the V1610 in the LCC. High-speed video images are shown in Fig. 4. The pre-return stroke frame captured by the M310 in Fig. 4A shows a FLF channel extending from ground up to an altitude of 172 m. Unlike Events 1-3, the FLF channel in this case does not

appear to be connected to the downward leader tip, which is located at an altitude of 202 m. *Tran et al.* [2015a] classified this type of FLF as a “group B” event. The FLF image shown in Fig. 4A also shows a complex optical signature from 17 m to 33 m above ground level with multiple loops in the FLF channel. Images such as this exhibiting low-altitude loops in the channel are typically associated with the attachment region, as shown by *Howard et al.* [2010], *Jerauld et al.* [2007], and *Rakov and Uman* [2003]. In this case, the FLF channel extends for 140 m above the looped section of the channel and the

downward leader tip is located nearly 170 m above the visible channel loops. The V1610 frame acquired two frames prior to the return stroke is shown in Fig. 4B. At the end of the frame, which occurred 34 μ s prior to the end of the M310 frame shown in Fig. 4A, the downward leader tip was located at an altitude of 270 m. No FLF were visible below the downward leader tip. At the end of the V1610 pre-return stroke frame shown in Fig. 4C, the downward leader had descended to an altitude of 149 m, below the top of the FLF region shown in Fig. 4A. The V1610 frame shown in Fig. 4C ended 26 μ s following the end

of the M310 pre-return stroke frame shown in Fig. 4A, but no FLF channel is visible. No dE/dt waveform data were available for this event.

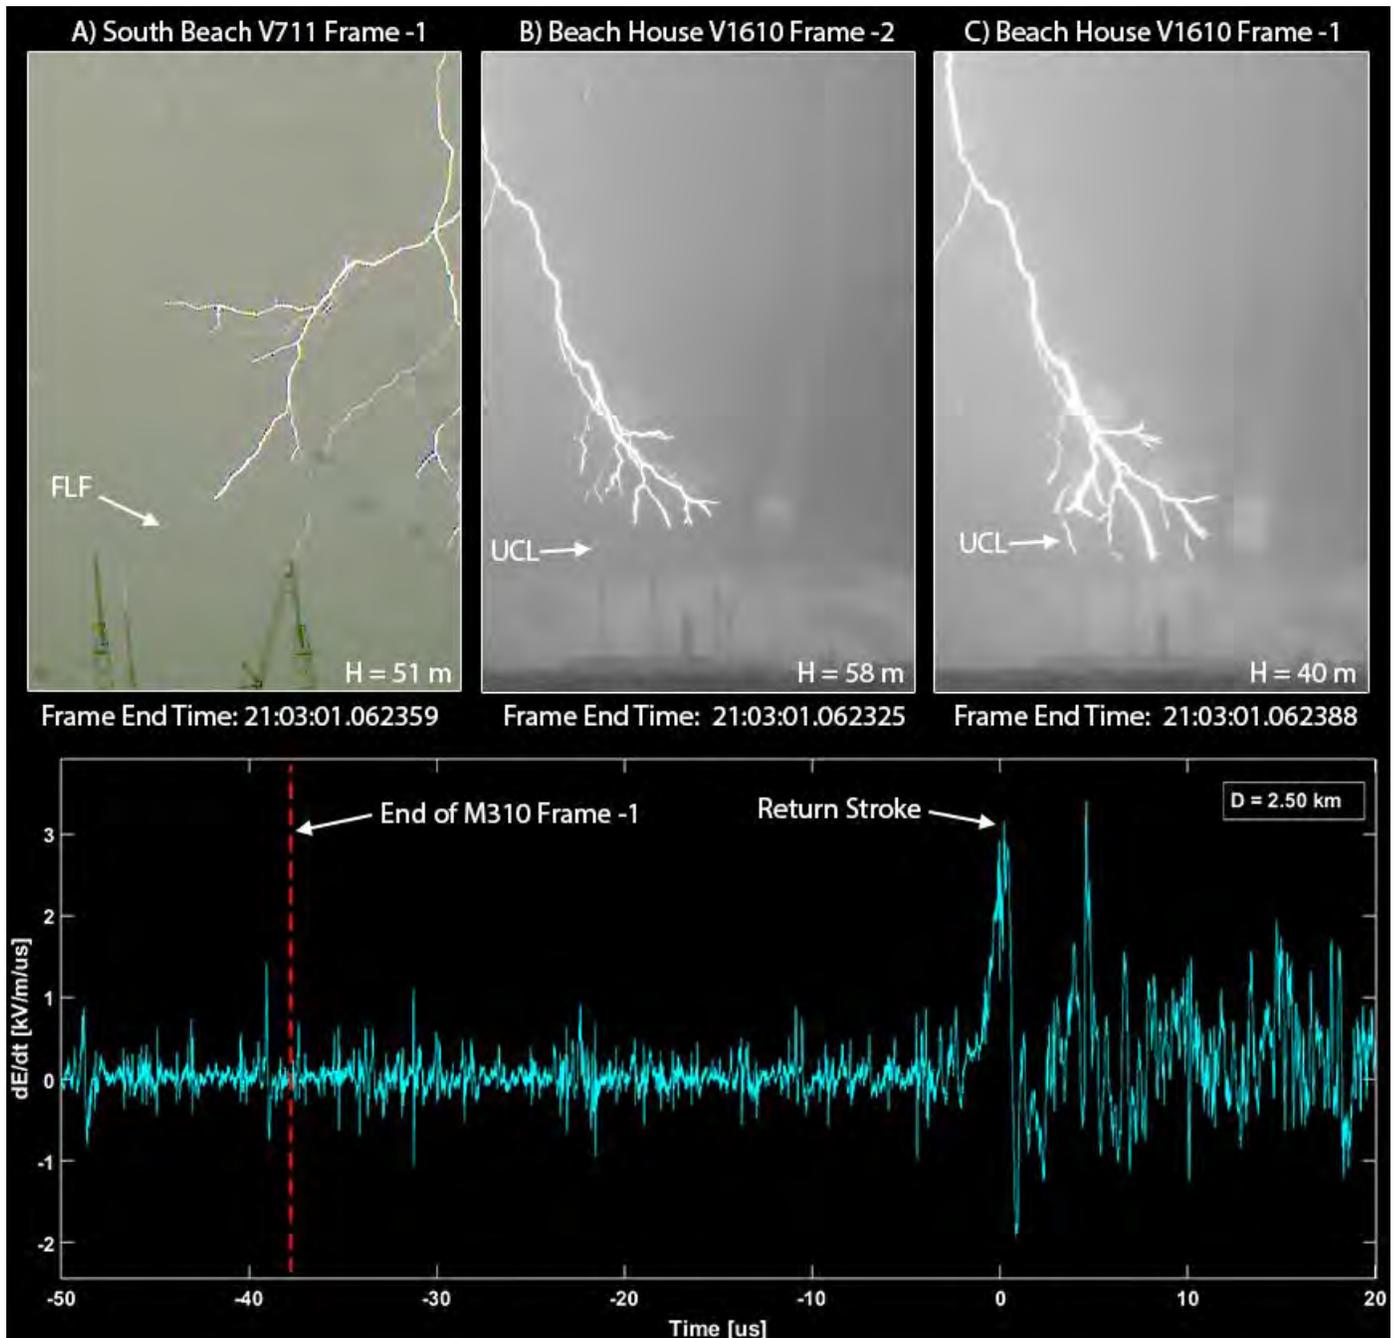
Fig. 5. Event 5 high-speed video images and dE/dt waveforms recorded on October 11, 2015 at 21:03:01.062 A) South Beach V711 pre-return stroke frame showing FLF and multiple unconnected upward leaders, B-C) consecutive Beach House V1610 pre-return stroke frames not showing FLF, but showing both a UCL and multiple unconnected upward leaders.

The final FLF presented in this paper was photographed at 21:03:01.062 on October 11, 2015. The stroke attached to the southwestern lightning protection system mast at Launch Complex 41. A V711 high-speed camera recorded the event from the South Beach camera site, located 718 m northeast of the strike location, while a V1610 recorded the stroke from the Beach House camera site, located 1,296 m to the southeast of the strike location. The V711 pre-return stroke frame in Fig. 5A shows the FLF connecting the top of the mast to the downward leader tip. In this case, the FLF channel exhibited a pronounced sharp bend. The total length of the FLF channel was about 75 m, with the leader tip about 50 m above the strike location. The V711 pre-return stroke frame also shows unconnected upward leaders initiating from the northwestern lightning protection system mast as well as the overhead catenary wire system and down conductors. The V711 pre-return stroke frame ended about $37 \mu\text{s}$ prior to the return stroke dE/dt peak shown in Fig. 5. The two V1610 frames captured prior to the return stroke are shown in Fig. 5B and Fig. 5C. In Fig. 5B, the downward leader descended to an altitude of about 58 m above the strike location. The frame also captured an upward leader propagating from strike location with length of about 22 m. No visible connection was present between the downward and upward leaders at the end of the exposure in Fig. 5B, which ended about $34 \mu\text{s}$ prior to the end of V711 pre-return stroke

frame in Fig. 5A. Additional unconnected upward leaders are also shown in Fig. 5B. Fig. 5C shows the downward leader descending to an altitude of 40 m above the strike location, with the upward leader extending 32 m above the strike location. Though difficult to resolve in Fig. 5C, there is a faint connection between the upward and downward leaders that is likely the initial interactions of the streamer zones prior to the full attachment. The V1610 pre-return stroke frame in Fig. 5C ended $29 \mu\text{s}$ following the end of the V711 pre-return stroke frame shown in Fig. 5A. As with the prior four events, the downward leader continued to propagate in a stepping manner following the establishment of the FLF shown in Fig. 5A.

The authors believe the analysis performed by Vision Research suggests that the FLF observations presented here and in the prior studies are likely not real lightning optical phenomena. All FLF events recorded in this study and in *Tran et al.* [2014, 2015a, 2015b] were observed in a single frame prior to the frame containing the return stroke. In all cases, the return stroke channel produces a significant saturation of the camera sensor in the frame following the FLF observation. Based on the analysis conducted by Vision Research, it is likely that the bright light due to the return stroke produces parasitic light leakage onto the previous frame, as described in the quotation above. For Events 1-3 shown here, this light leakage effectively traced the exact path between the tip of the downward leader in the frame prior to the return stroke and the eventual strike point. For Event 4, the light leakage not only traced the path of the leader, but also showed complex characteristics of the attachment region that occurred a more-typical 17-33 m above the ground compared to the upper extent of the FLF region, which extended 172 m above the ground. A post-return stroke frame captured by the V1610 in the LCC is shown in Fig. 6. The attachment region channel loops shown in the M310 image of Fig. 4A are clearly present in the post-return stroke image as well. For Event 5, the light leakage traced the path between the downward leader tip and the strike point, and based on the two images captured the V1610 of the UCL propagation (Fig. 5B and Fig. 5C), likely also obscured the UCL captured by the V711. Note the V711 resolved

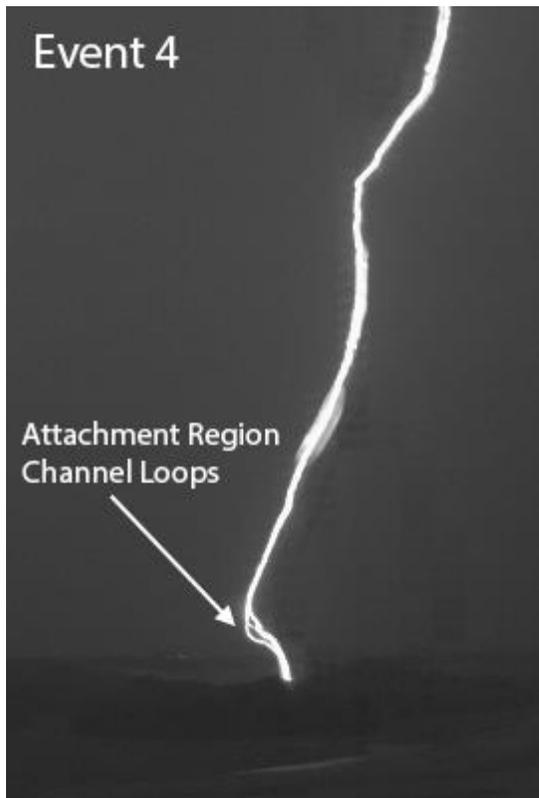
Fig. 6. Post return-stroke LCC V1610 frame recorded during Event 4 on August 30, 2015 at 12:11:22.438 showing channel loops from 17-33 m above ground level. The channel loops are typically indicative of the region where the attachment process occurred.
